D'APPOLONIA CONSULTING ENGINEERS INC PITTSBURGH PA
NATIONAL DAM INSPECTION PROGRAM. CLOVER DAM (NDI ID NUMBER PA-4--ETC(U)
JUN 80

PHASE I REPORT
NATIONAL DAM INSPECTION PROGRAM

NAME OF DAM: Clover Dam
STATE LOCATED: Pennsylvania
COUNTY LOCATED: Jefferson
STREAM: Clover Run, a Tributary of the East Branch of Mahoning Creek
SIZE CLASSIFICATION: Small
HAZARD CLASSIFICATION: High
OWNER: Western Pennsylvania Water Company
DATE OF INSPECTION: April 22, 1980 and April 30, 1980

PHASE I REPORT
NATIONAL DAM INSPECTION PROGRAM
CLOVER DAM
(NDI LD PA-420)
(DER LD 33-4)

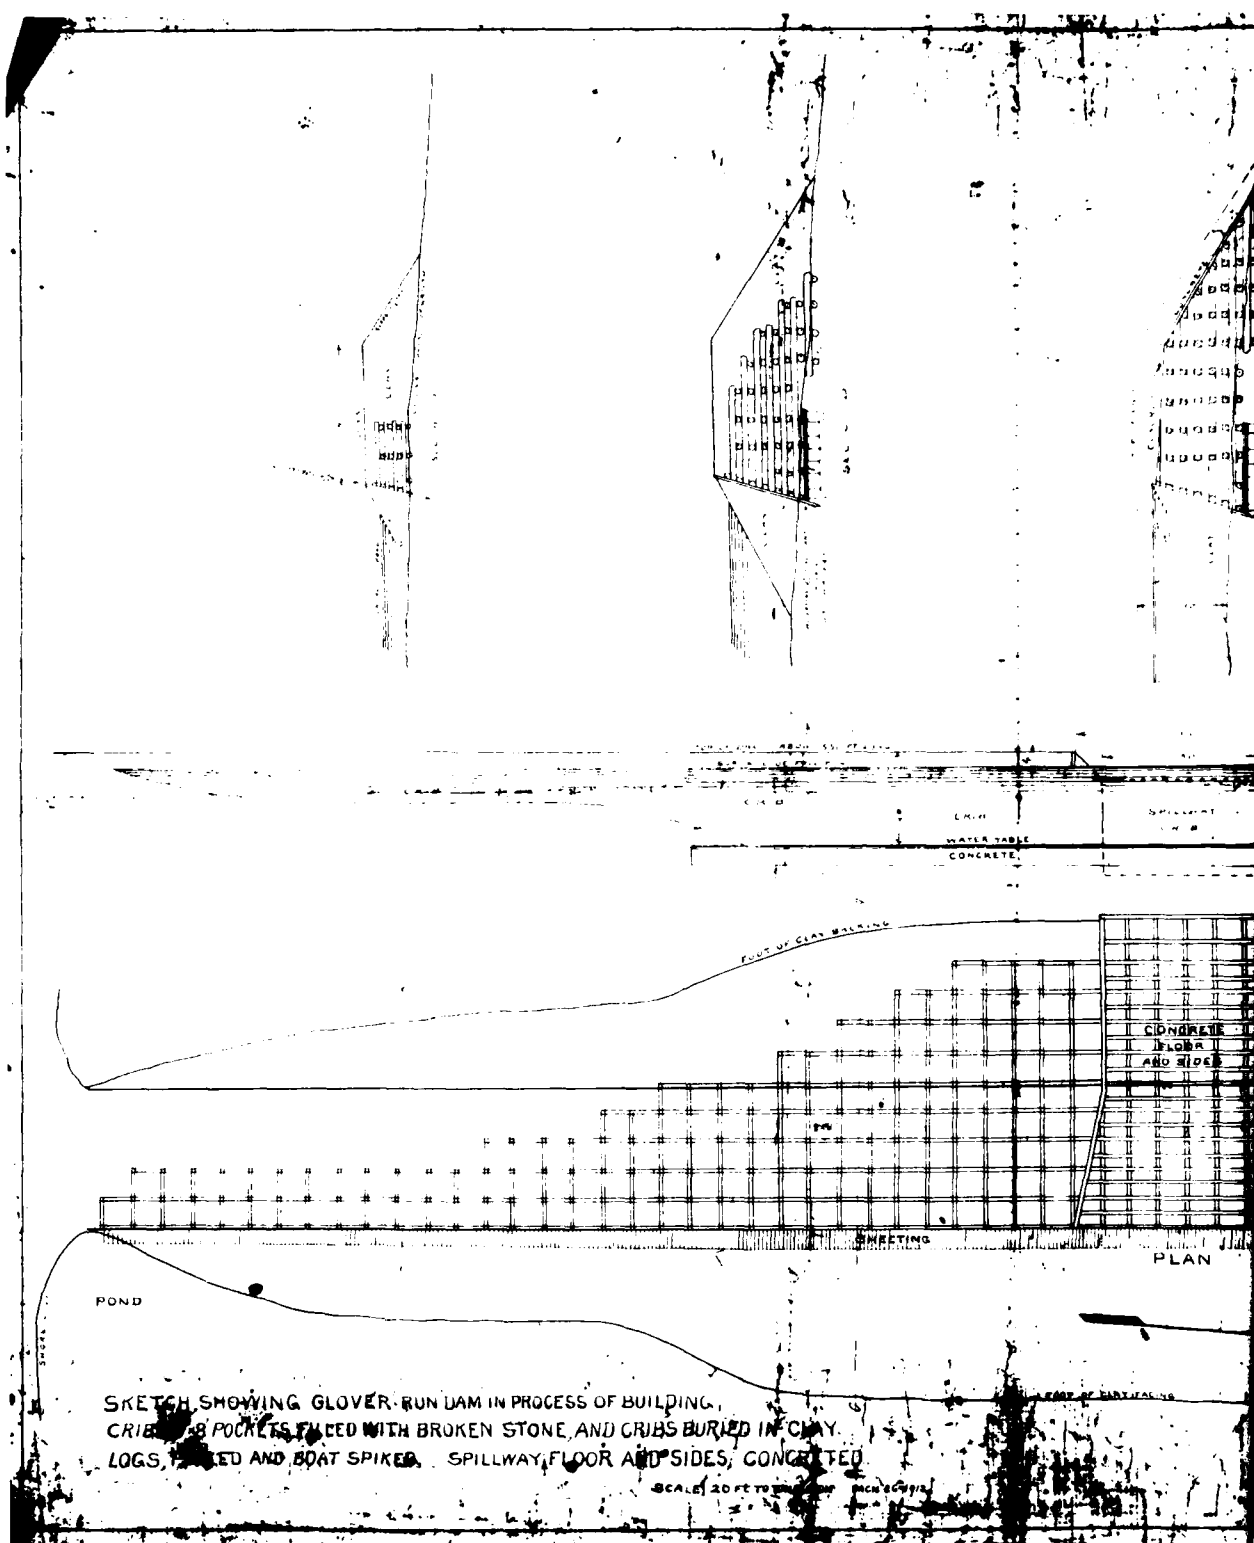
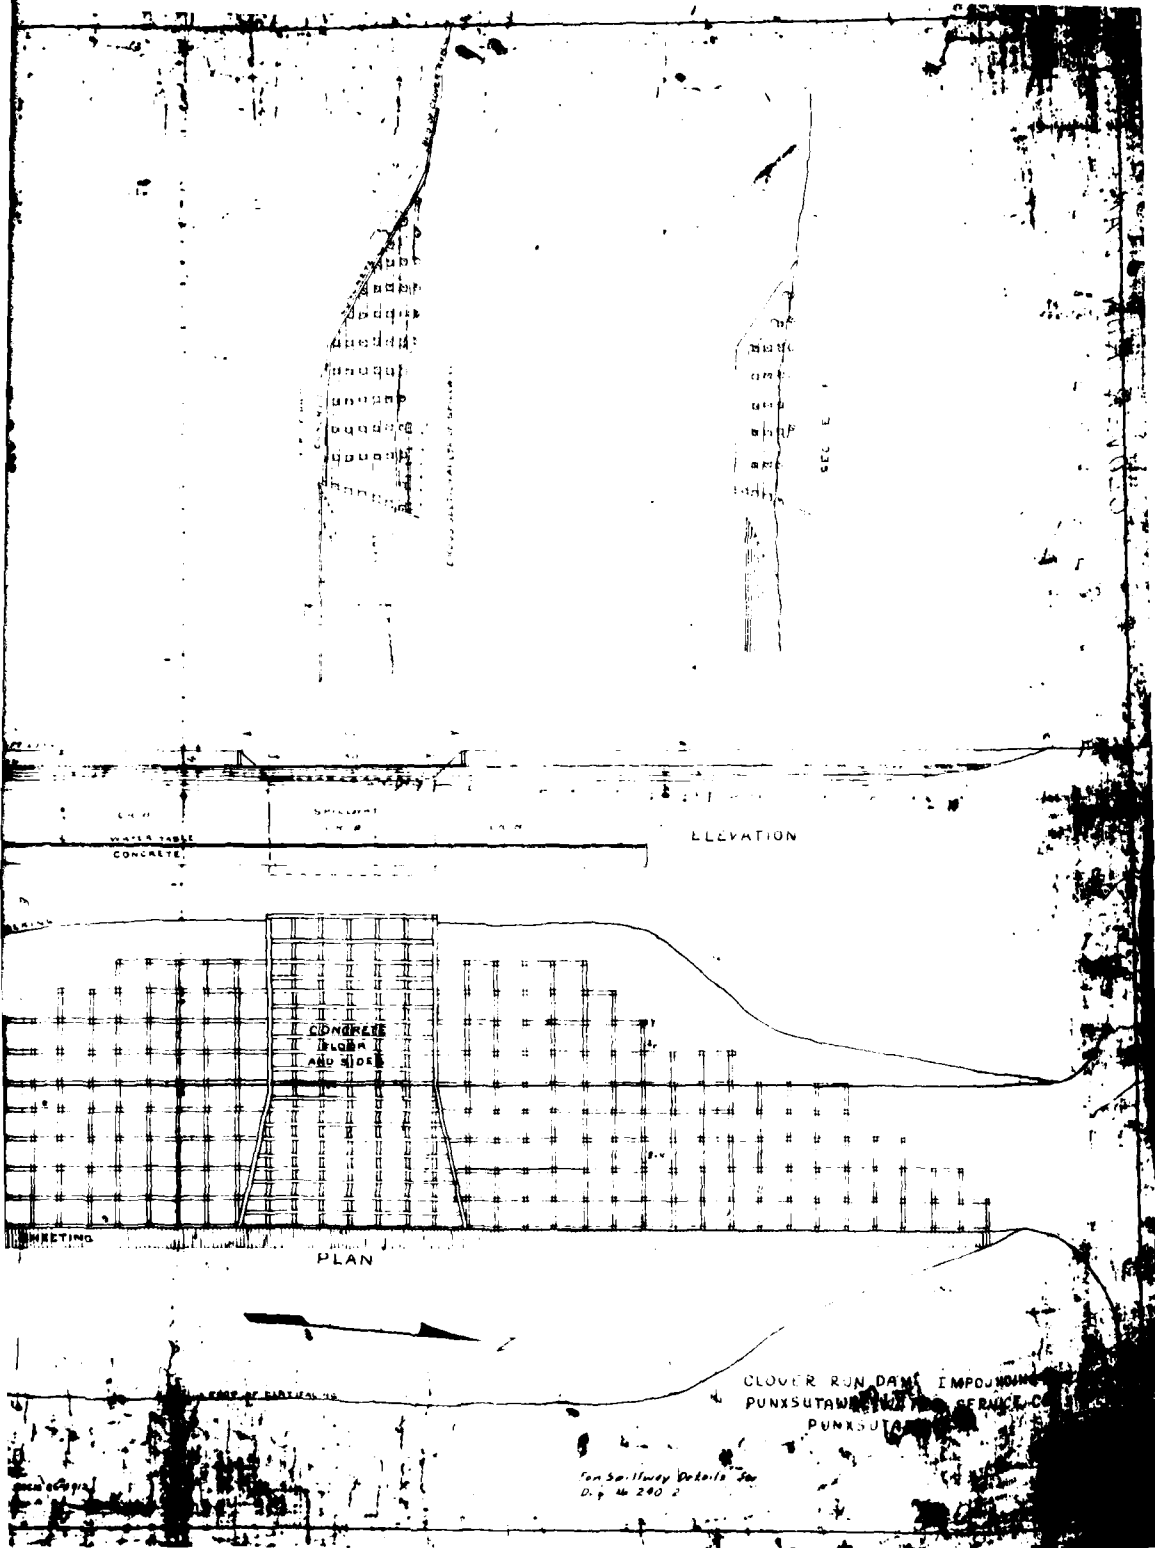
PLATE 2

(1) Embankment. Plate 2 illustrates the plan and typical cross sections of the dam. The dam as built in 1896 consisted of a timber crib structure filled with stone and earth material with an essentially vertical upstream slope and a 1.5H to 1V downstream slope. The records indicate that while most of the timber cribbing was placed directly on the natural ground surface, a 4-foot-thick, 20-foot-wide concrete mat was constructed as the foundation for the timber cribbing in the middle 200-foot section of the embankment. It was further noted that on this prepared foundation, two layers of 2-1/2-inch-thick pine planks were fastened to the concrete and the first row of timber cribs was nailed to the planking. The presently existing upstream steel sheet piling was constructed in 1974. Plate 3 illustrates the details of the steel sheet pile construction.

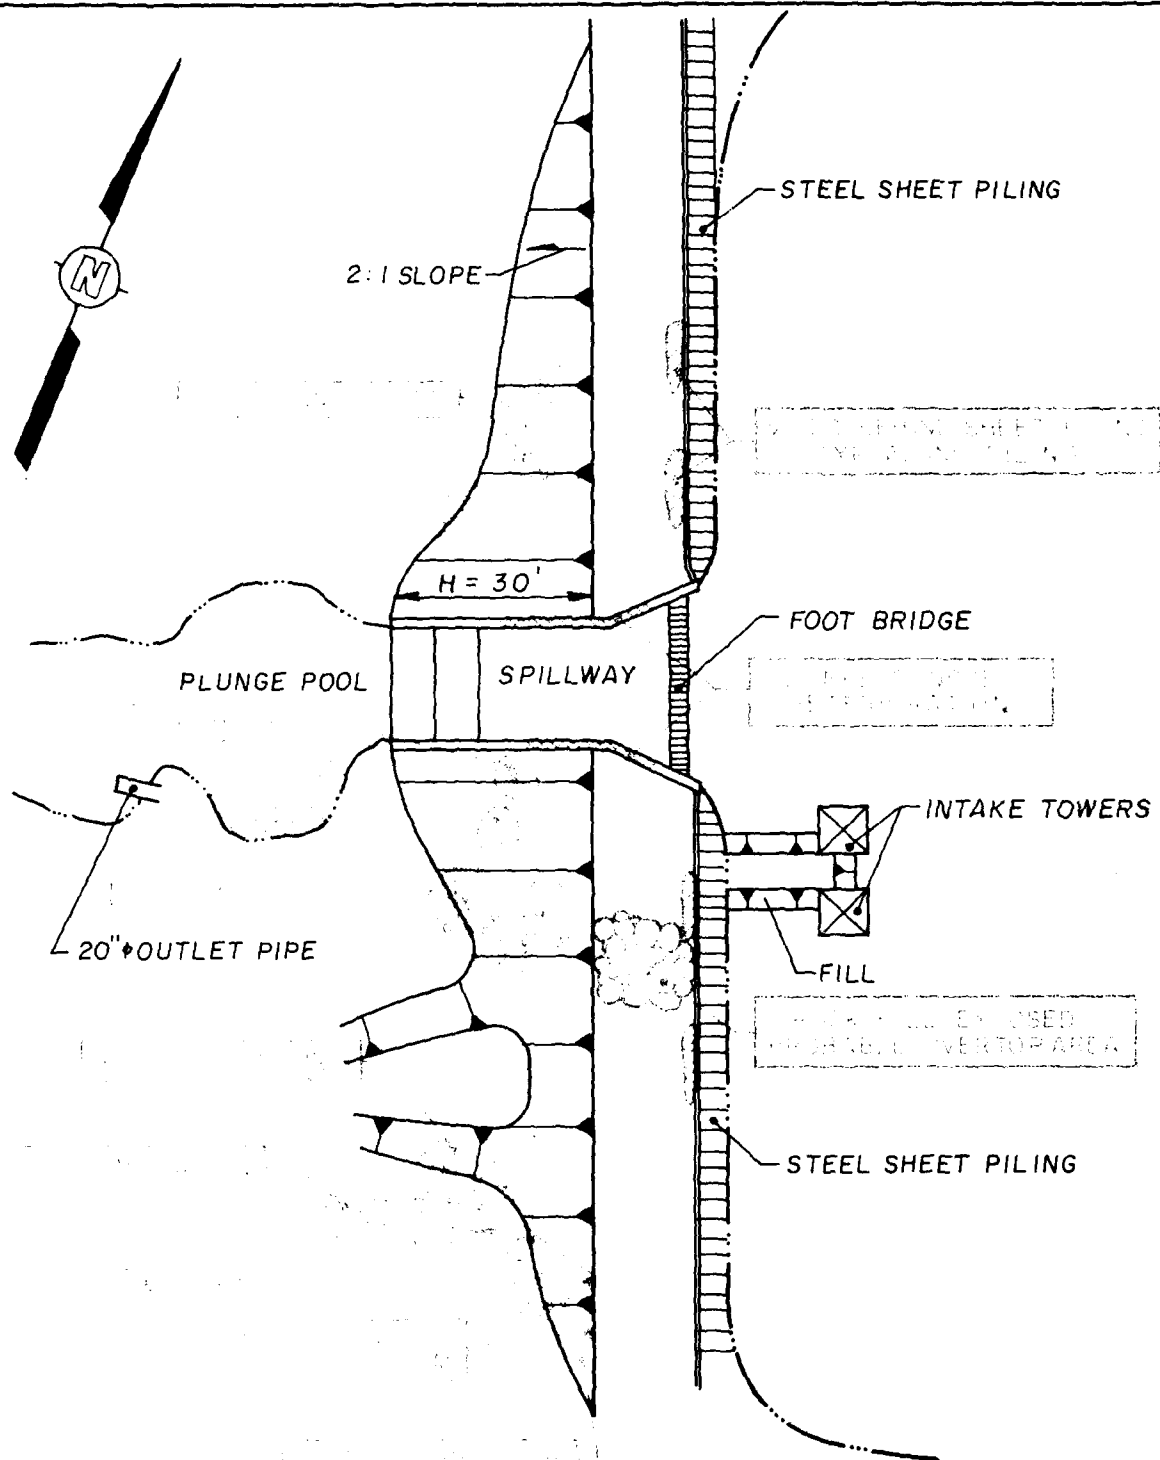
The crest of the dam was surveyed relative to the spillway crest elevation and the middle of the embankment was found to be on the order of 2 to 3 feet below the abutment levels. Plate 5 illustrates the longitudinal profile of the dam crest along the top of the upstream sheet piling and along the center of the embankment. The

downstream slope was surveyed at several locations and was found to range between 2.5H to 1V on the right side of the spillway to almost 1H to 1V near the left abutment.

The detailed evaluation of the dam should include, but not be limited to, subsurface investigation, material testing, instrumentation, and stability and seepage analyses. In conjunction with the detailed investigation, the crest of the dam should be surveyed and filling of the low areas along the crest of the dam should be considered.
